## ESSAR BERTH Vizag (India)

Essar Ports GCB

### THE PROJECT

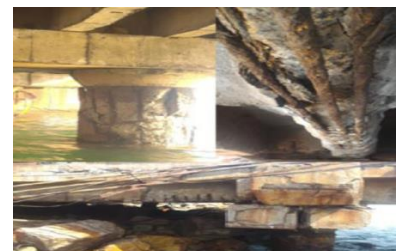
Essar Steel's Jetty berth is a deep water terminal located in the outer harbor of Vizag Port, with a length of 360m and width of 20m, capable of berthing 150,000 DWT vessels. The Berth facility handles heavy cargo of major industries. Due to aggressive sea water exposure, the structural components such as girder beams were corroded, with severe spalling, badly exposing reinforcement. The structure was in a severely distressed condition and hence necessitated structural rehabilitation.

Severely spalled and distressed structural members (underside of the berth)

After the appropriate non-destructive tests were carried out to assess the condition of the structure, scaffolding had to be suspended from the top of the berth by drilling holes and connecting them with T-joints to get a stable platform for workers to carry out the rehab work. Nitozinc Primer was used as an anti-corrosive primer coating on the damaged steel reinforcements. Lokfix was used to anchor new reinforcements. Renderoc SP40 wet spray mortar and Renderoc DS40 dry spray mortar were used as structural grade reinstating mortars to repair all the damaged areas of the berth. Nitobond AR was used as bonding agent cum curing compound. Nitocote PE 135, a chemical resistant cum waterproofing protective coating, was used over the reinstated berth area.

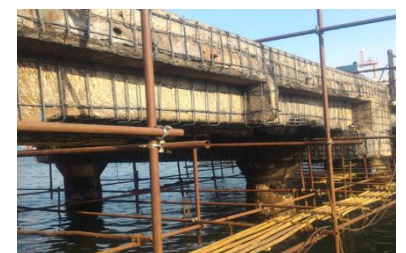
Scaffolding suspended from the top using T-joint connections

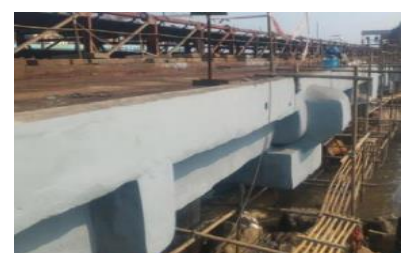
A reinstated structural members finished with Nitocote PE 135
